Home Inspection Report

Happy Dr
Cincinnati OH

Darrin Bachman
Licensed Home Inspector / ASHI Certified

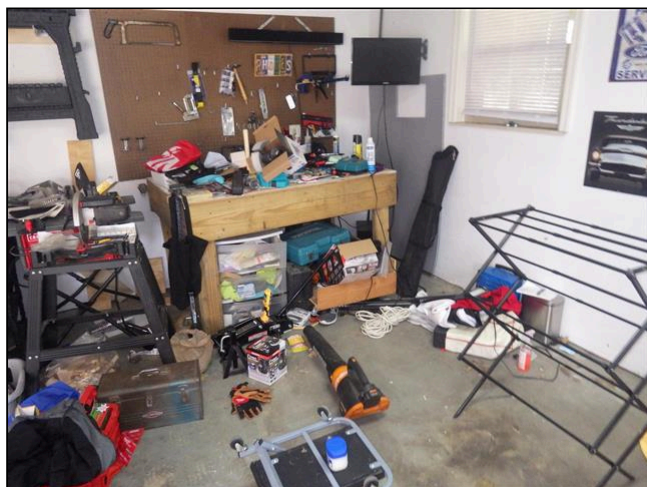
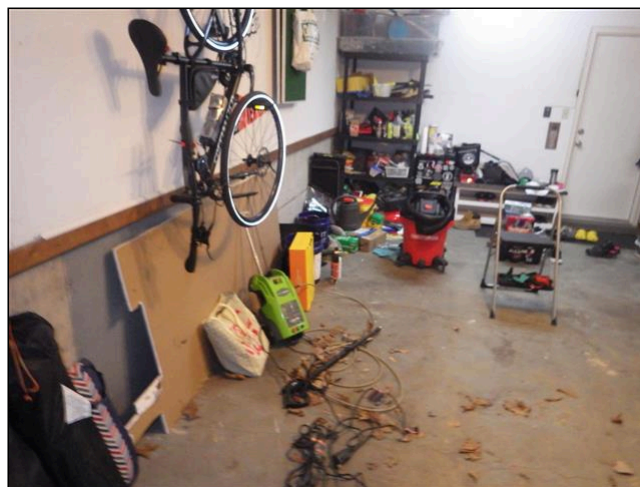
Information: Garage, stored items along the wall(s), limited access and visibility.

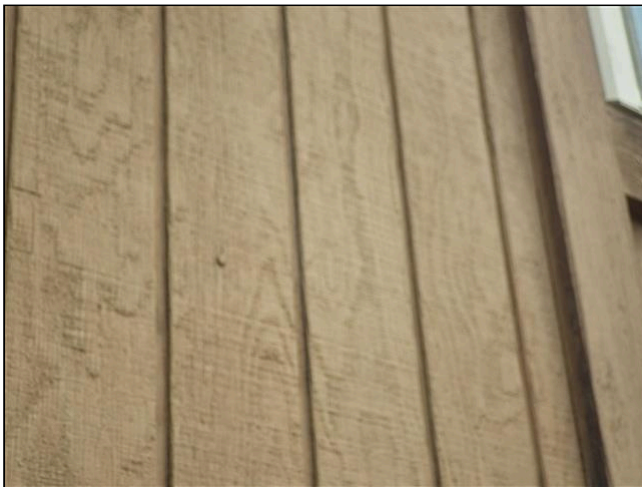
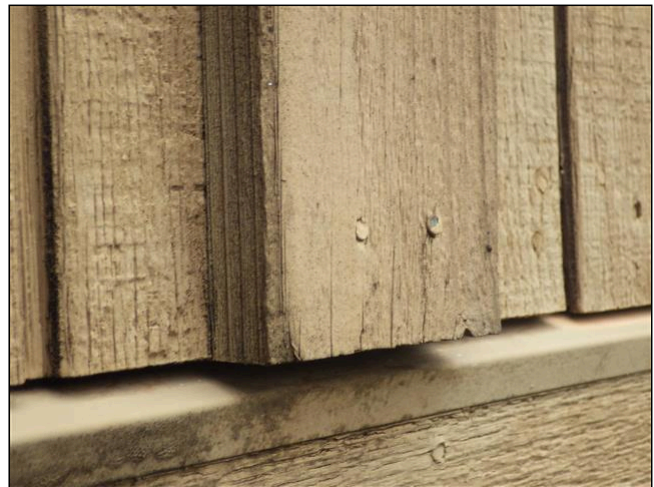
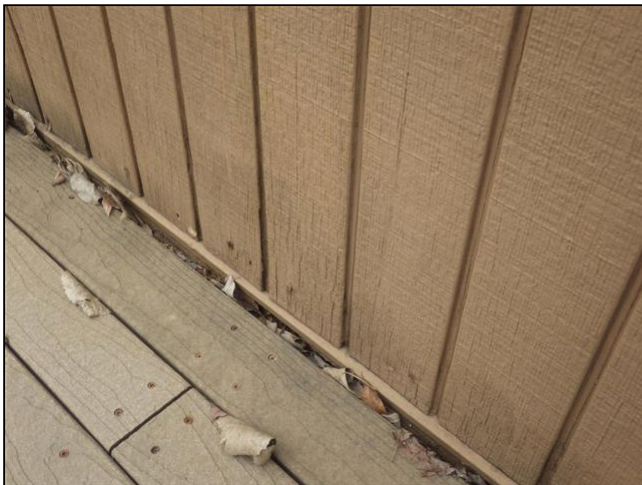
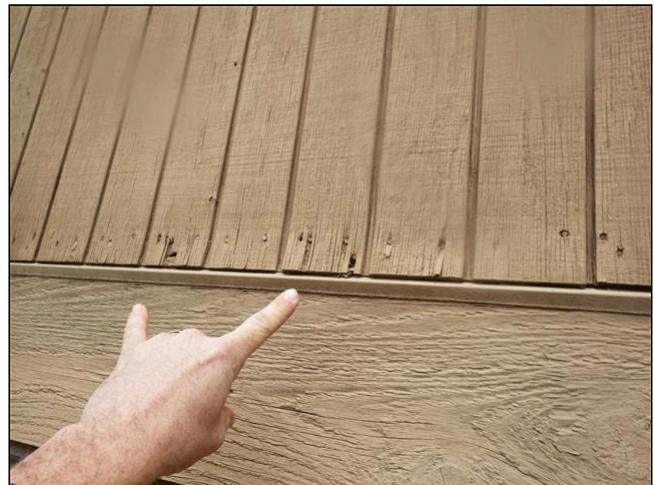
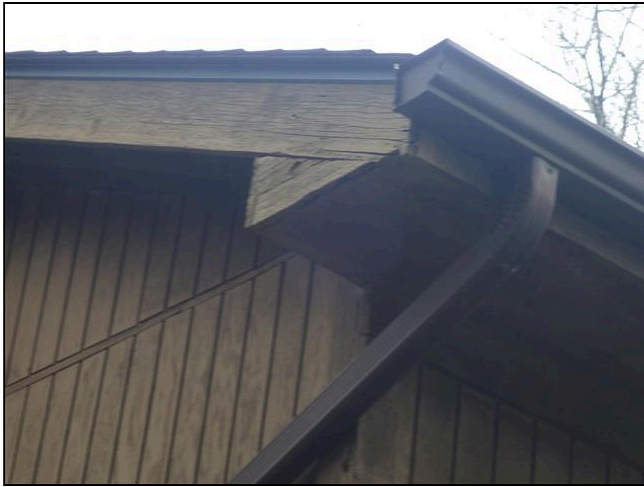
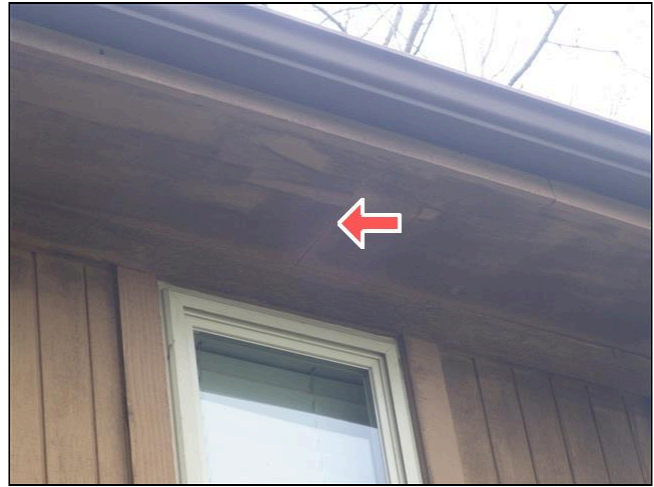
(2) Repair: Most of the perimeter, paint is failing on the siding and trim. If the paint is not kept intact deterioration will occur. During preparation for painting damaged materials may be identified requiring replacement. Recommend a qualified contractor to properly Repair, seal and paint as needed.

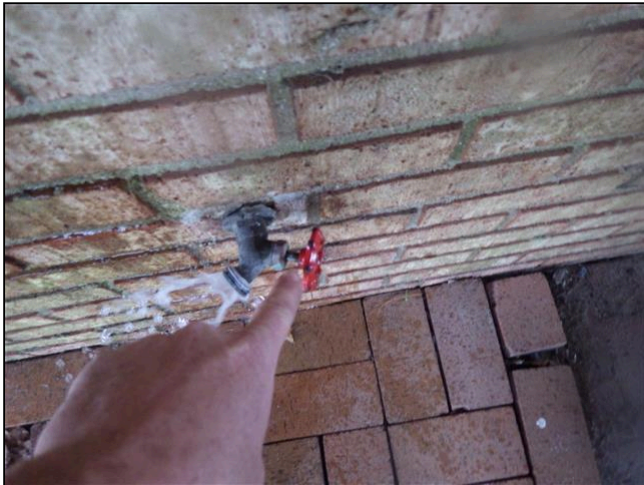
Information/Maintenance: The exterior hose bib is not a "frost proof" faucet. If the faucet is not properly winterized these are subject to freezing causing water leaks. When covered in the on position, leaking at the valve stem occurs. Recommend a plumber to correct as needed.

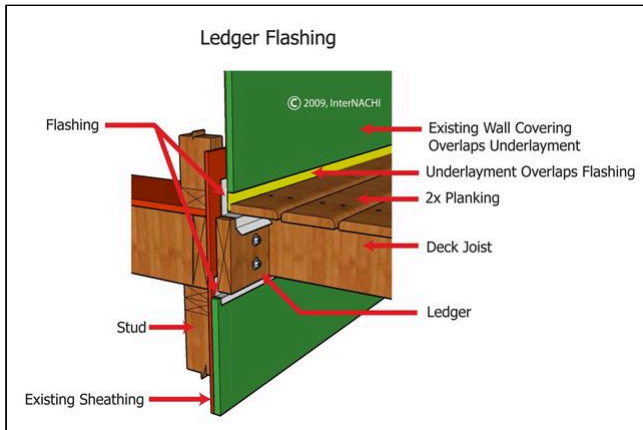
(1) Repair/Further Assessment: Back deck ledger board is not properly flashed. Flashing materials are not visible at the ledger board, this will commonly allow water to enter the building framing causing deterioration, visibility is extremely limited. Recommend a qualified contractor to further assess for water intrusion into the building framing members and correct the ledger board flashing as needed.

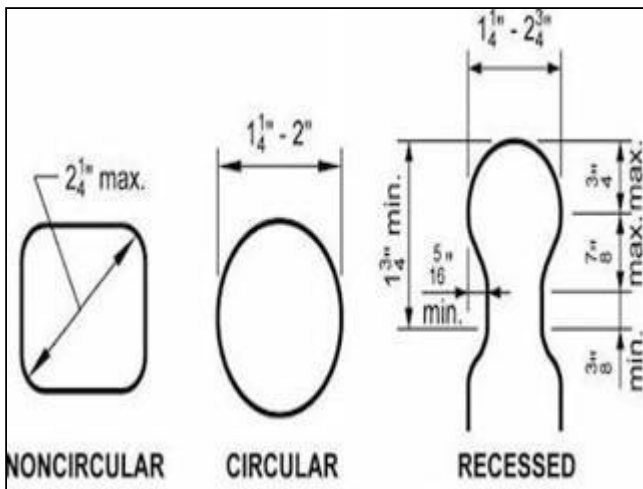
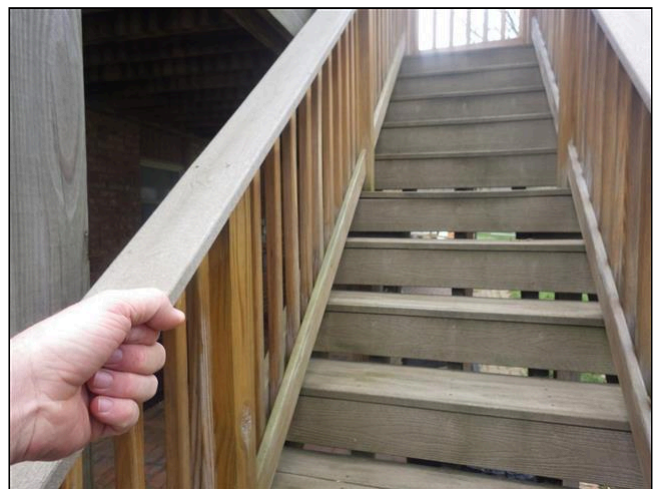
(2) Safety: Back deck stairs, top of railing can not be properly gripped per good practice. Recommend installing an appropriate hand railing that can be properly gripped/held.

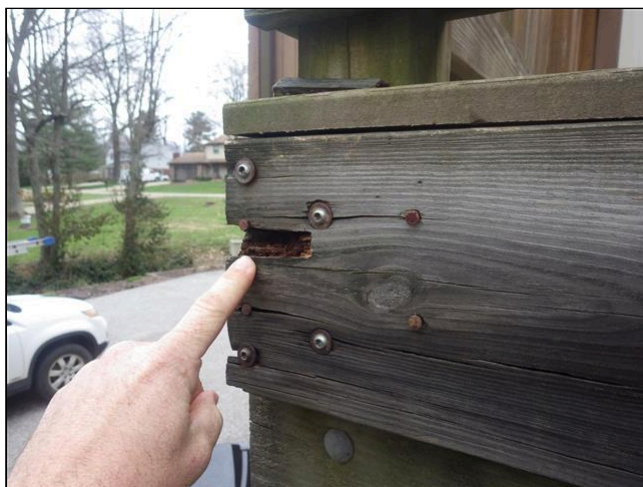
(3) Repair: Rear of the home, deck band board is deteriorated from moisture. Recommend a qualified contractor to further assess all deck wood and repair/replace as needed.

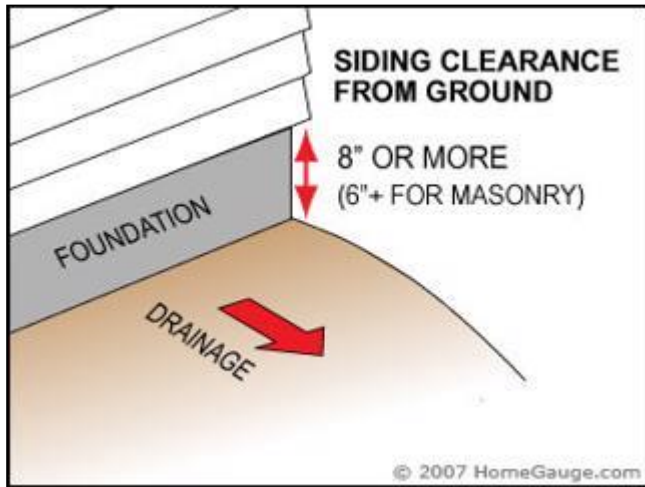
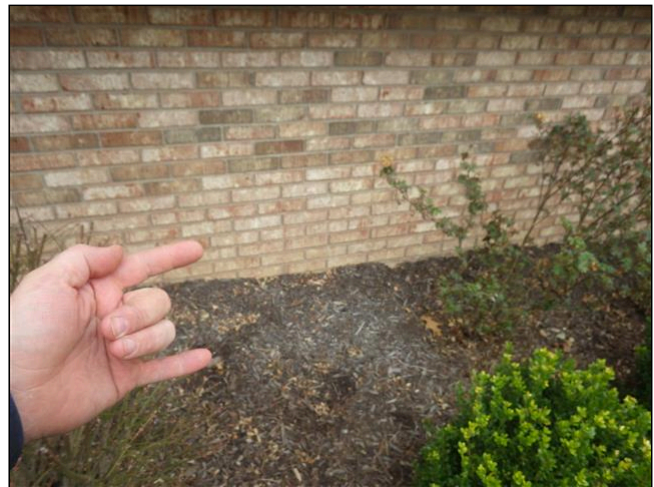
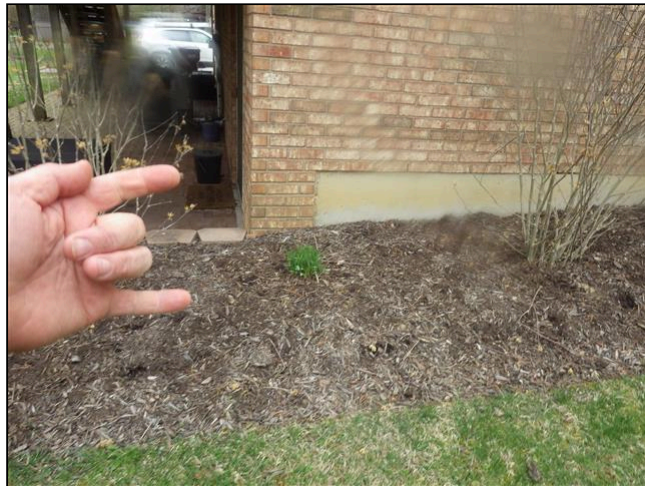
Maintenance: Most of the perimeter, the siding does not have a minimum of 6" clearance above grade per best practice. The clearance is to prevent moisture from penetrating into the building framing and provide a line of site for inspection purposes. Recommend removing soil/mulch as needed insuring that the clearance is present and proper positive grade for water drainage is maintained. Correct as needed.

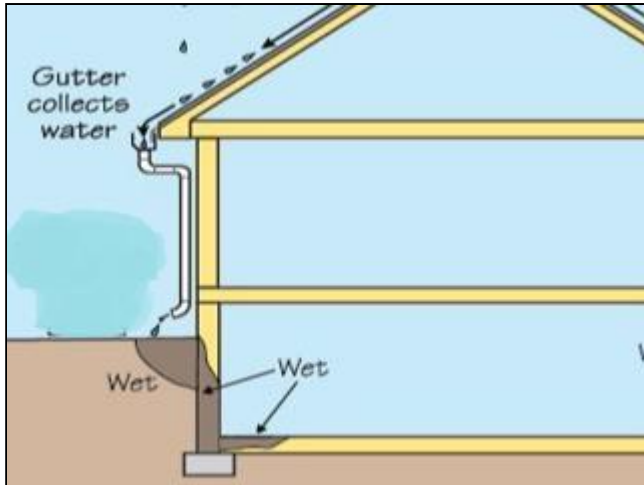
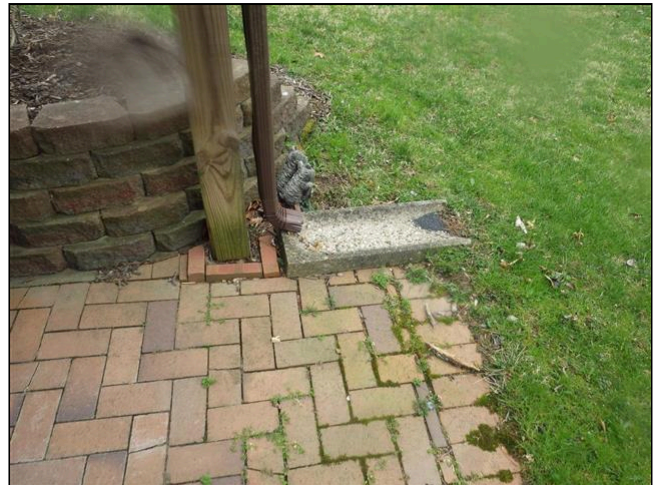
(1) Maintenance: Roof gutter downspout(s) discharge within 5' of the building structure, per best practice the gutter downspouts should discharge a minimum of 5 feet from the building, +10 feet is optimal. Drain lines should not drain onto concrete sidewalks, patios and or driveways. Short gutter downspout terminations may contribute to water entry into the building foundation and or create other moisture related concerns. Correct as needed.

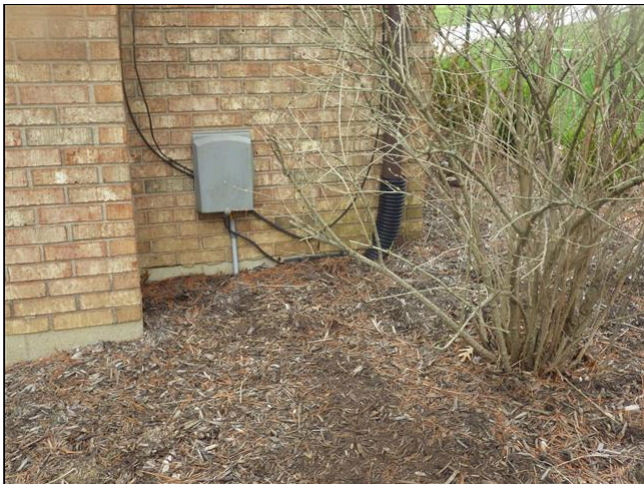
(2) Information: Gutter downspouts feeding into below grade drain lines are present, unable to determine if drains will function properly. It is not uncommon for the below grade lines to not function properly possibly contributing to moisture/water in the basement.

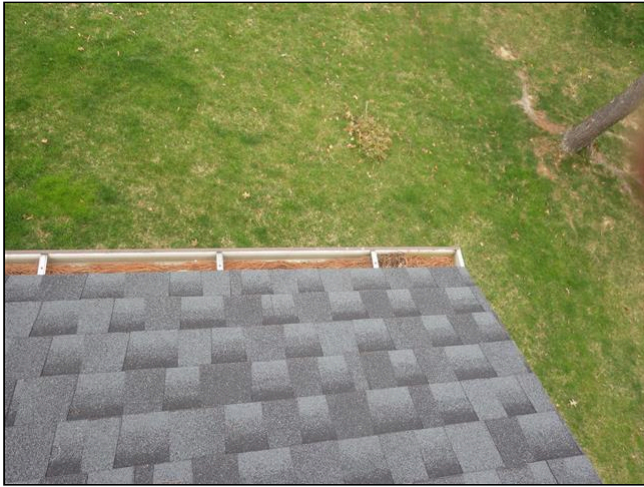
Maintenance: Gutters and downspouts need to be cleaned. In the event the gutters become clogged interior water leaks can occur when water runs back along the eave possibly entering the interior building structure. Recommend cleaning gutters and downspout as needed, as general maintenance this will need to be done multiple times a year.

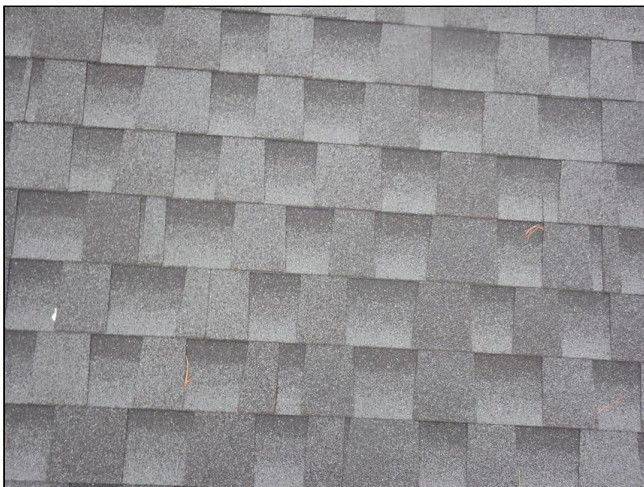
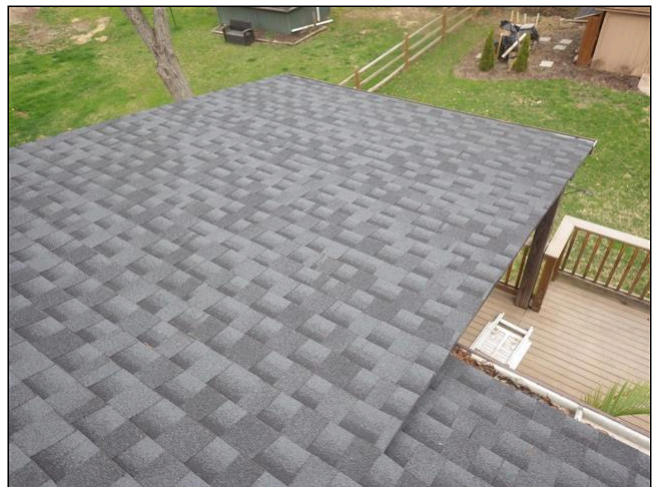
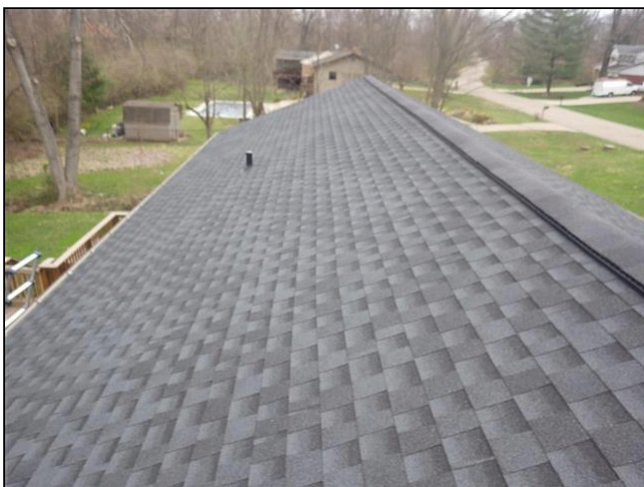
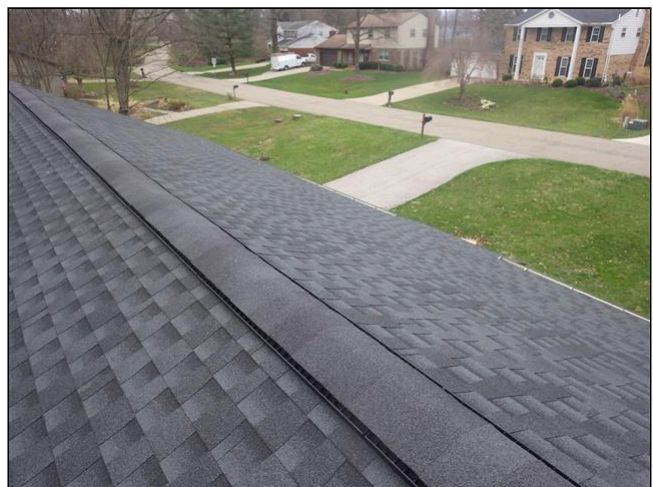
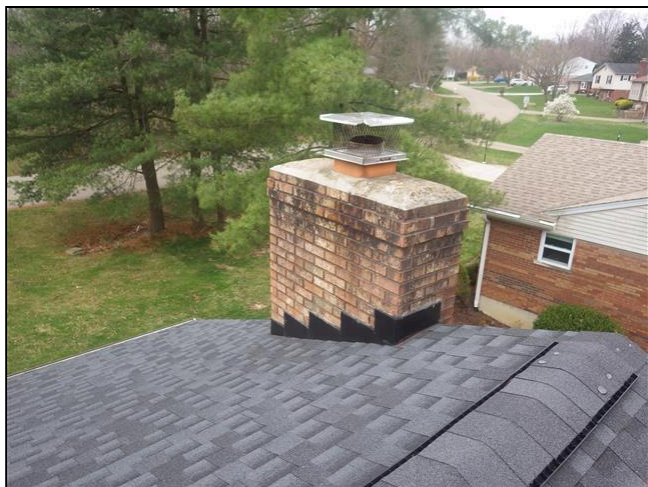
Information: Architectural/Laminate asphalt shingles commonly last 20 to 25 years in this area.

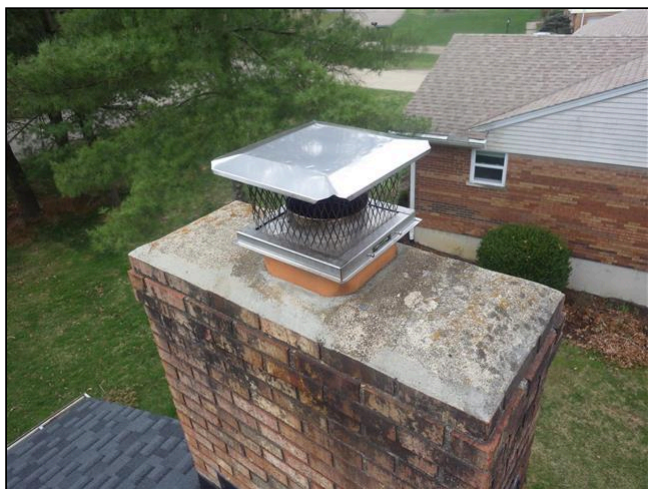
(1) Information: Chimney, flue cap with screen is present. I can not view down the flue from the top of the chimney. Flue was not inspected.

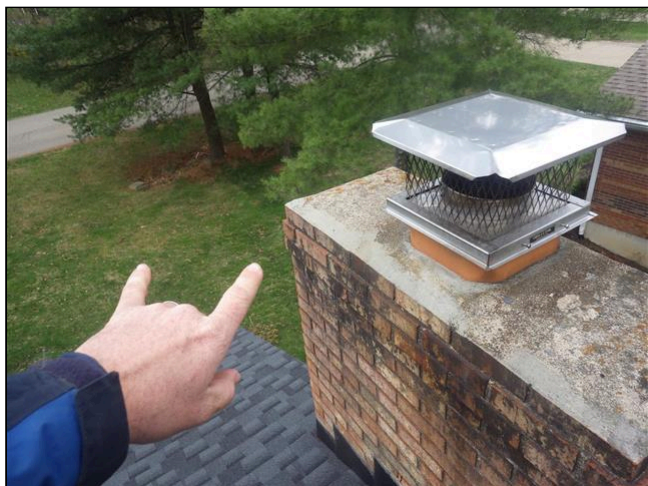
(2) Improvement: Chimney(s), concrete crown does not have an appropriate overhang of approximately 2" or greater per current best practice. This can allow water to flow down the chimney/chase and encourage moisture entry, deterioration of mortar and other material, spalling, etc. Recommend a qualified chimney sweep or contractor to further assess and correct as needed.

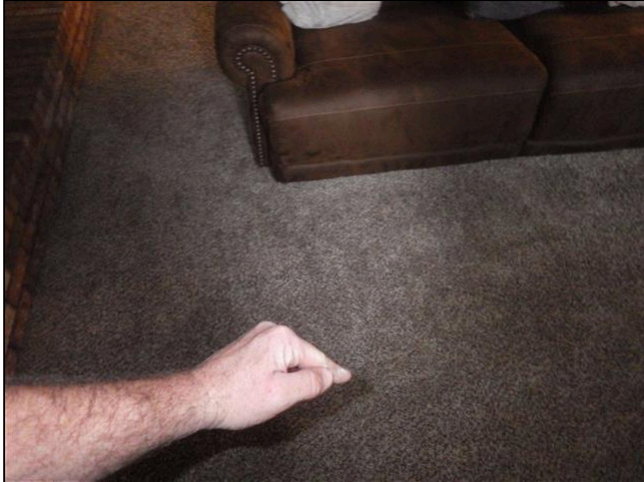
Information: Floors are not level in all areas.

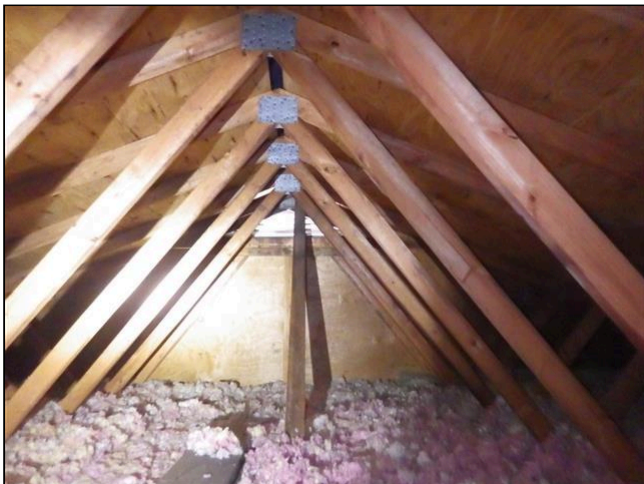
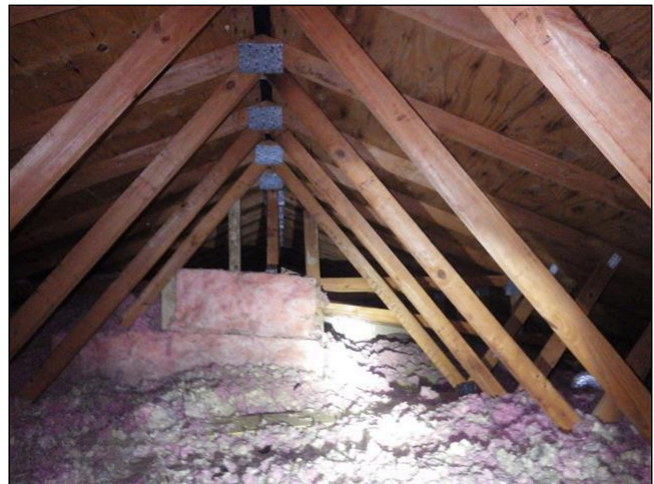
Information: Attic spaces, due to the limited access, all areas cannot be viewed or physically accessed.

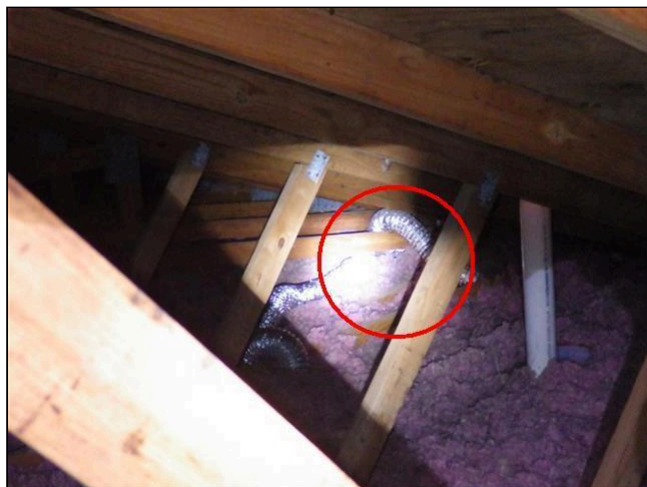
Repair: Bathroom ventilation fans, ducts vent into the attic at the soffit. Due to the small size of the soffit, this is poor practice. Recommend venting the fans to the outside not into the attic, recommend insulating ducts to prevent condensation. Bathroom exhaust fans are intended to remove moisture from the room. Correct as needed.

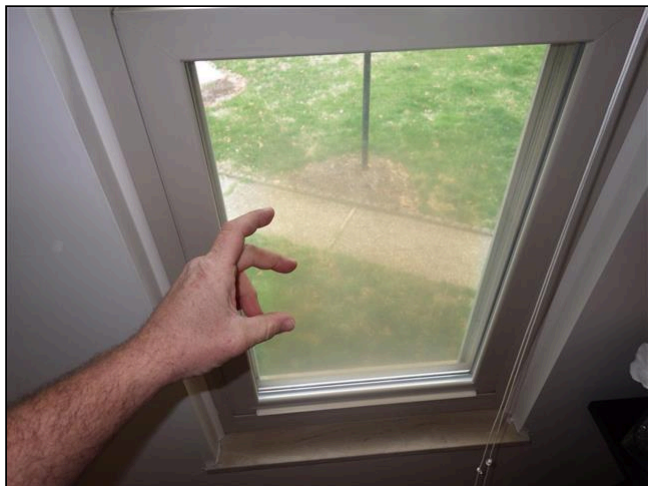
- 🏠 Repair: Front middle bedroom window (sealed insulating glass unit) has discoloration present between the panes of glass indicating the "Low E Coating" has failed. Correct as needed.

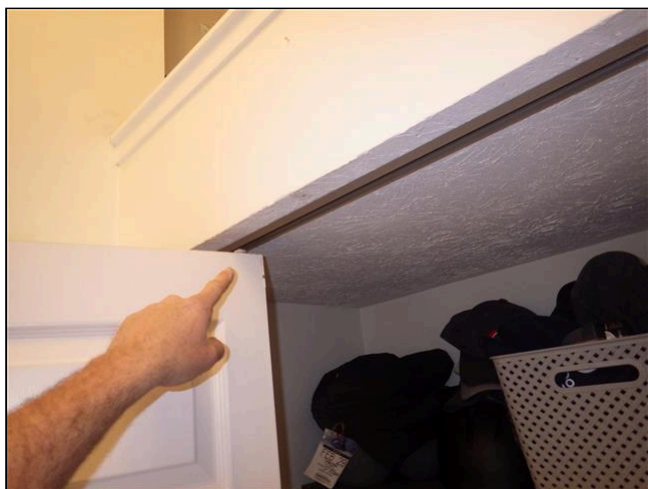
Maintenance: Entry closet door hardware is improperly secured/installed - door does not retain in the guide. Correct as needed.

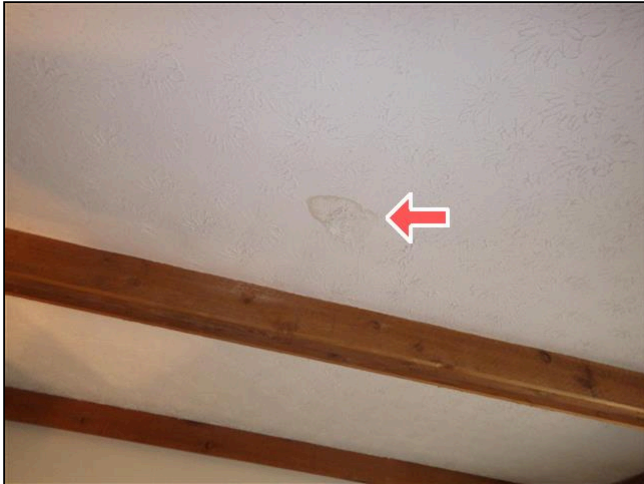
Information: Dining area ceiling has water stains. I cannot determine if these are or are not active leaks. Per owner, leaking occurred several years ago and has not occurred since recent roof covering has been installed.

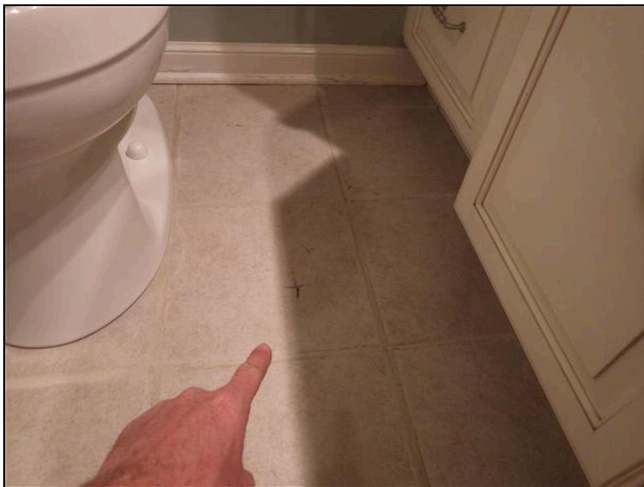
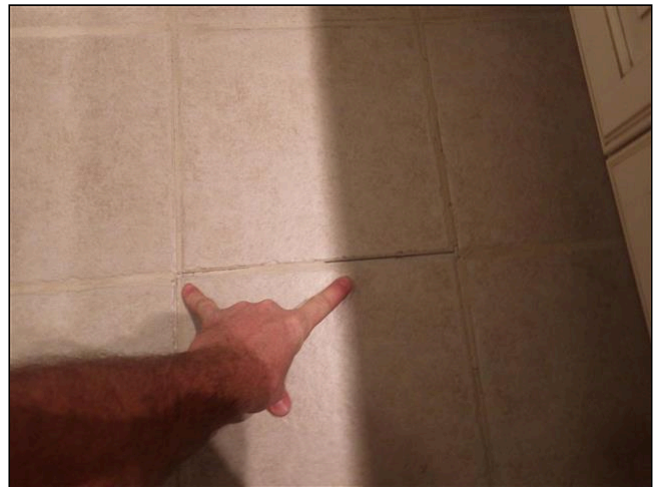
Maintenance: Hall bathroom, floor tiles are broken/cracked in areas and grout is missing along the center of the room. Correct as needed.

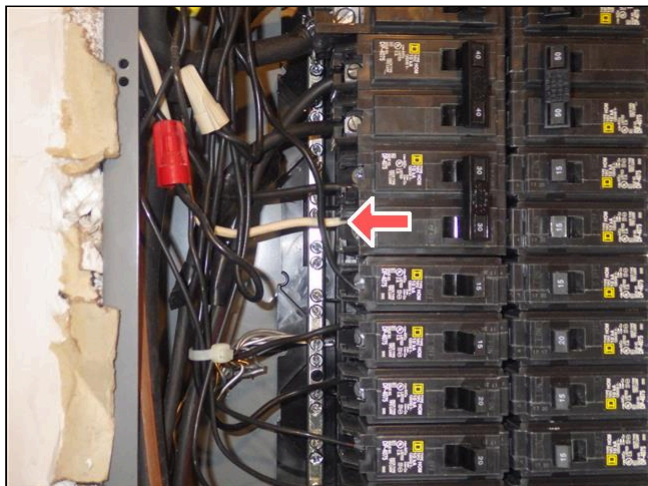
(1) Improvement: Electric distribution panel, double-pole breaker has installed black and white conductors. White-sheathed conductors are allowed but should be colored, taped, or otherwise marked to confirm they are intended for use as a (hot) conductor. Recommend owner (if qualified) or licensed electrician to confirm proper installation as needed. If unable to do so, recommend a licensed electrician to further assess and repair/correct as needed.

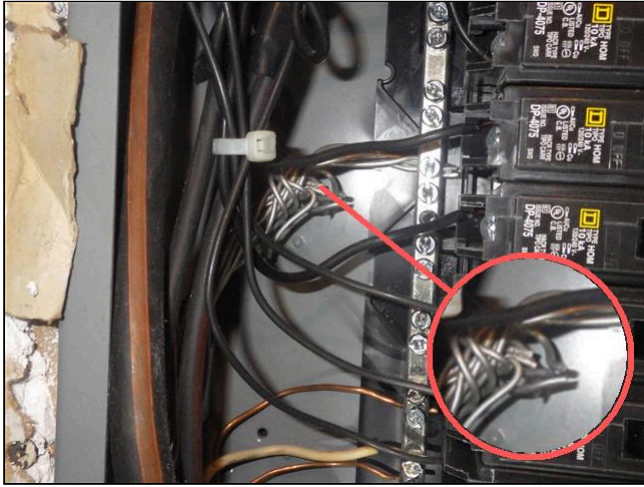
- 🏠 (2) Repair: Within the distribution panel, neutral wire (stranded aluminum) is not properly installed at the buss bar. Recommend a licensed electrician to correct as needed.

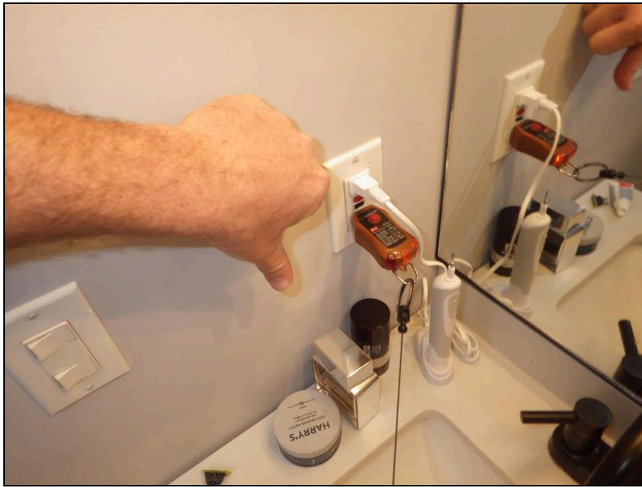
- 🏠 Repair: Master bathroom, GFCI does not trip when tested-power remains on. In this condition the GFCI receptacle does not provide the intended safety function. Recommend a licensed electrician repair/correct

as needed.

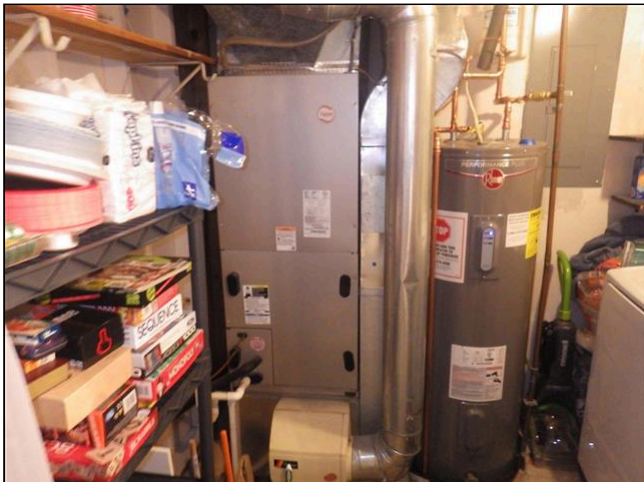
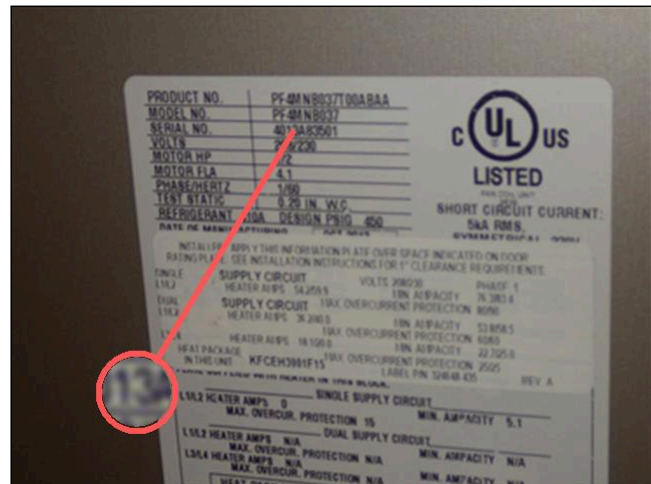
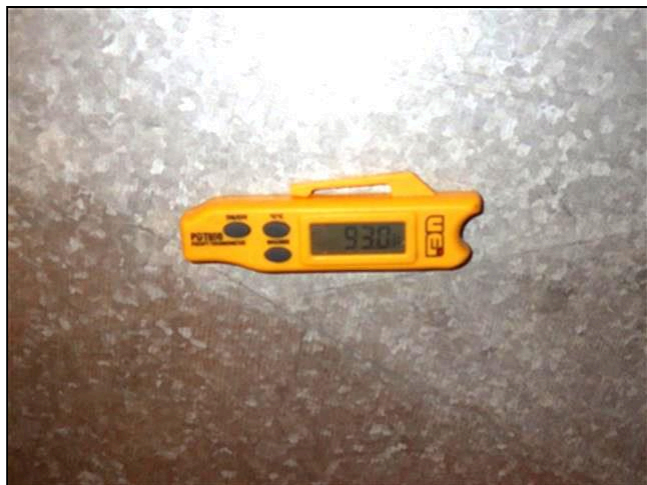
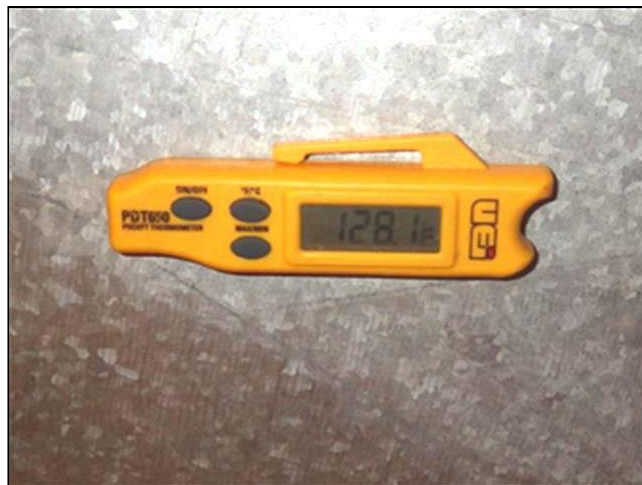
Information: The heat pump air handler and resistance heat is approximately **9 years old**, if well maintained per the NAHB (see footer notes) the heat pump should have an **average life of approximately 16 years**. As equipment ages the efficiency of the unit will commonly decline and it is common for it to become more problematic and subject to failure.

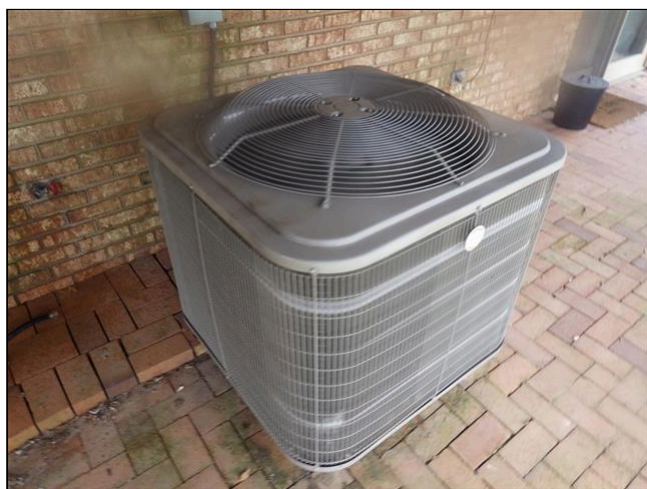
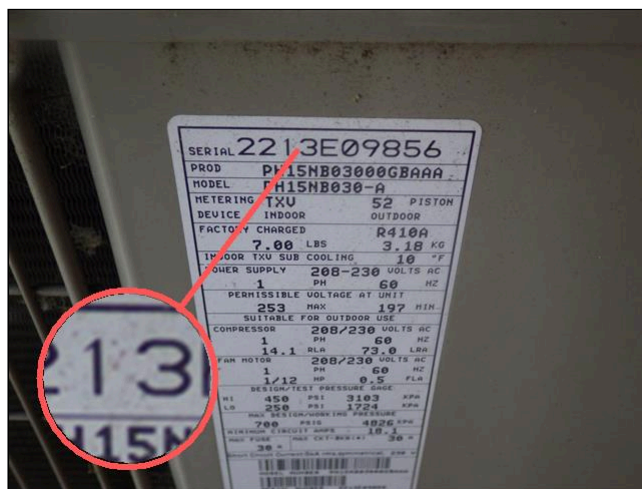
Information: The Heat Pump Compressor is approximately **9 years old**, if well maintained per the NAHB (see footer notes) heat pumps have an average design life of approximately 15 years. As equipment ages the efficiency of the unit will commonly decline and it is common for it to become more problematic and subject to failure. **The heat pump is inspected in the seasonal mode of heat only.** Resistance/emergency heat at the air handler is inspected in all seasons.

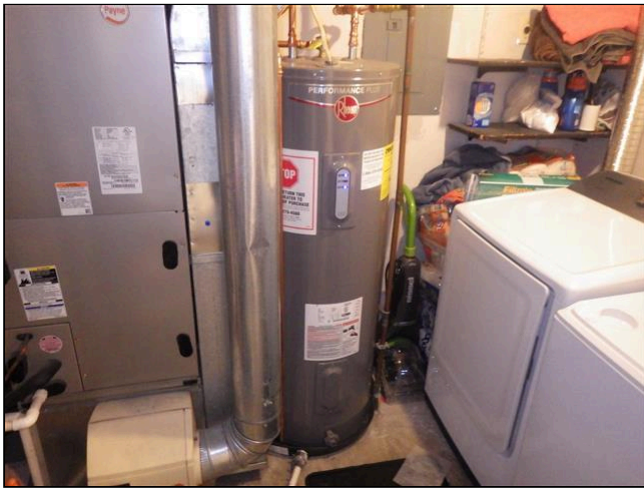
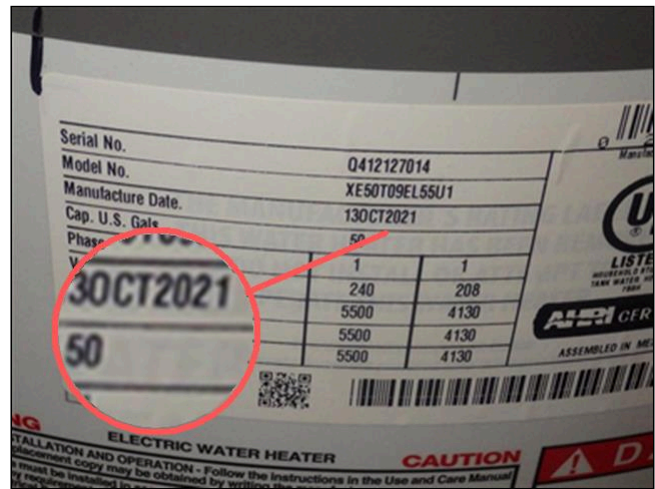
Information: The water heater is approximately **1 year old**, per the NAHB water heaters will have an **average design life of 12 years**.

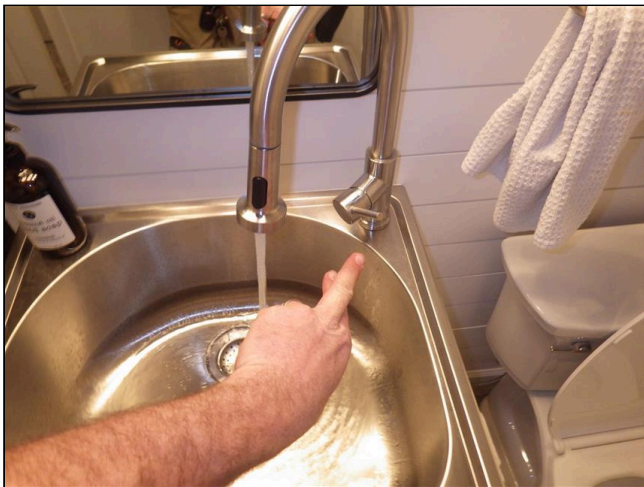
Maintenance: Basement bathroom, sink hot/cold are reversed. Correct as needed.

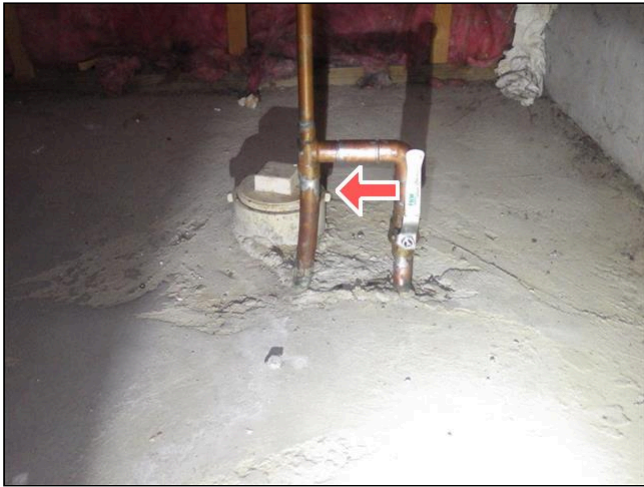
Basement - Under the Stairway

Information: Sewer waste line cleanout is accessible. Cleanout cap is PVC.

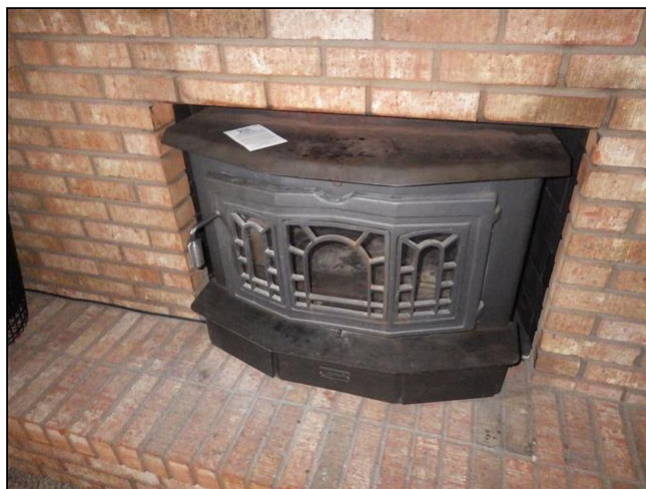
Not Inspected/Further Assessment: Fireplace, a wood burning insert is present. The firebox, damper and flue is not visible from the opening. Recommend a qualified chimney sweep clean and inspect for safety and function. (Per documentation on-site, chimney sweep has recently inspected)
